Larsen Bay rental #5 – propane stove conversion to electric
1201 First St.

Panel replacements:
Cliff Wood 1319 Selief Lane

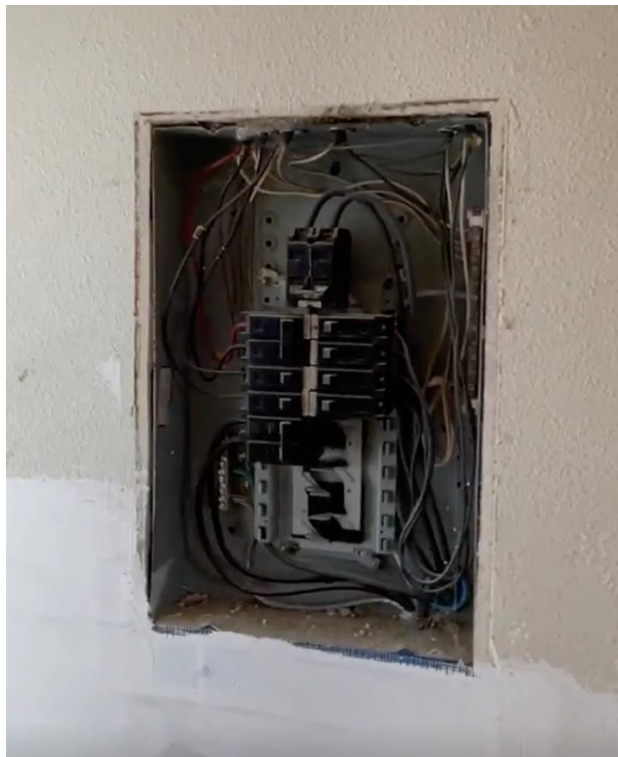
Akhiok Homestart Lot 6A Block 2

CB MAIN PANEL 62: The protective 'dead front' cover, which helps prevent hazardous shocks, is missing from the service panel. We recommend it be replaced.

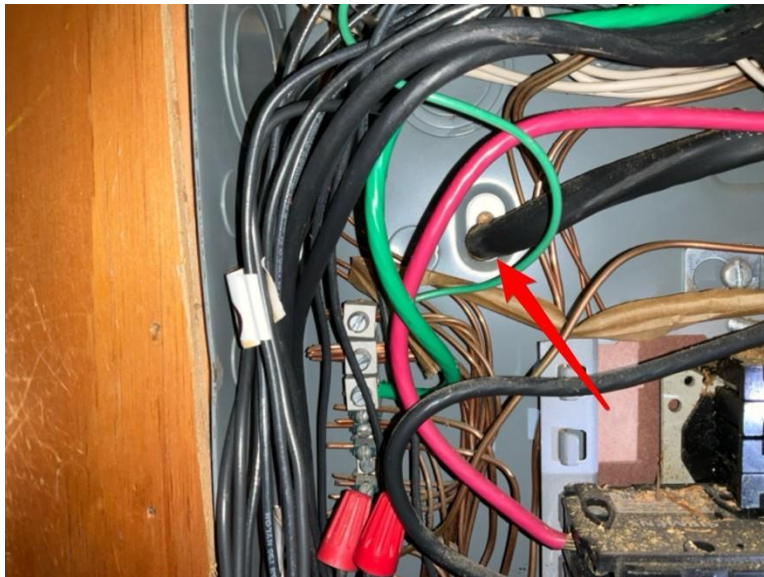
Subpanel 65: Wires are loose where it enters the subpanel. Recommend the cable be secured by installing an approved connector.
